Exposed Pipeline is Once Again Protected Thanks to ARMORFORM

Pipeline case study (continued)

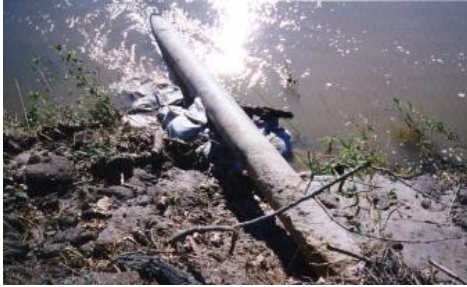
A once buried pipeline that is now exposed can be of serious concern. When Colonial Pipeline found out that a 16" diameter pipeline that had once been buried well beneath Raccoon Creek in North Georgia was now exposed they required immediate action.

Exposed 16" diameter pipeline caused by the natural relocation of Raccoon Creek.

In December of 1995, shortly after the exposed pipeline was discovered, Colonial Pipeline had a crucial decision to make. The pipeline obviously needed to be re buried. The options were to close the pipe, refit it and re bury it below the now relocated creek bottom or to simply move the creek back to its original position. The first option appeared to be the easiest thing to do, however, shutting down the pipeline would cause serious down time and there was no guarantee that the creek would not relocate itself again and cause the pipeline to be re exposed. Upon further inspection of the site it was discovered that the outer bank of the creek was now less than 20 feet away from a 500,000 volt electrical tower! It was obvious that the creek would have to be moved.

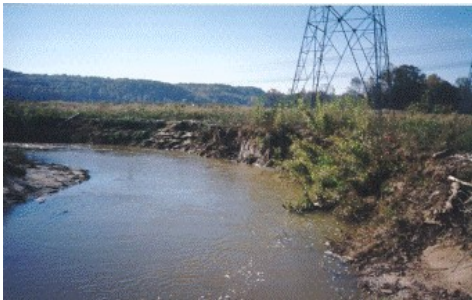
A 500,000 volt electrical tower is dangerously close to the edge of the creek's outer embankment.

It was decided to relocate a 250 feet long curved section of the creek in order to re bury the exposed pipeline and to protect the electrical tower. The creek would have to be moved over 40 feet thus creating a much sharper bend than that which was formed naturally, and there was evidence in the surrounding terrain that the creek frequently overtopped its banks. It was obvious that there was the potential for a serious erosion problem. Hard armoring of the creek's embankments would be necessary.

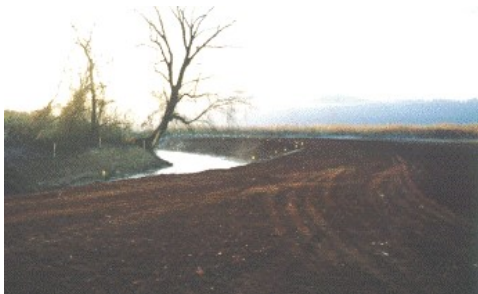
After grading was completed the creek was effectively "moved" to re bury the exposed pipeline. Also note that the electrical tower is now far away enough from the outer embankment to be out of the photograph.

Once the side slopes were graded to the desired angle, an "anchor" trench was cut at the top of each slope. This trench is located approximately 1 foot back from the top of the slope and its purpose is to provide an anchor or "toe-in" for the ARMORFORM mats. This anchor will help reduce the possibility of the mat from sliding down the slope, however, its primary function is to prevent scour at the top of the slope caused by water flowing outside of the creek's banks when a flood occurs. A geotextile filter fabric supplied by *Mirafit* was installed directly over the subgrade to prevent the loss of fines when water passes through the open areas of the concrete mat. The ARMORFORM panels were then placed on top of the geotextile and temporarily held in place by placing sandbags around the edges. During the inflation process the sandbags are simply pushed off of the ABM as the injected grout thickens the mat.

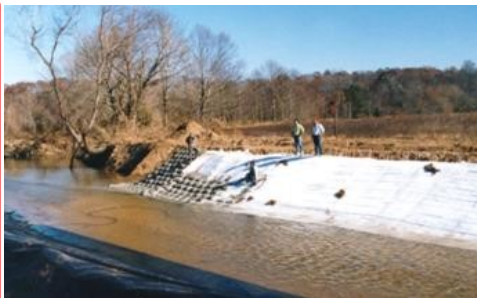
ABM panels being inflated on the inside embankment. Note the geotextile filter fabric on the slopes of the outer embankment in the foreground.

The ARMORFORM panels were installed starting at the downstream end first. By working downstream to upstream, panels could be overlapped onto one another in the flow direction so that water could not infiltrate the system. Access to the project site was limited to 1 side of the creek, however, the armoring was required on both embankments. The work crews simply carried the light weight ABM panels across the creek and unrolled them into place. The grout was then pumped through a hose and into the ABM from the opposite side of the creek where the pump and the trucks delivering the concrete were located.

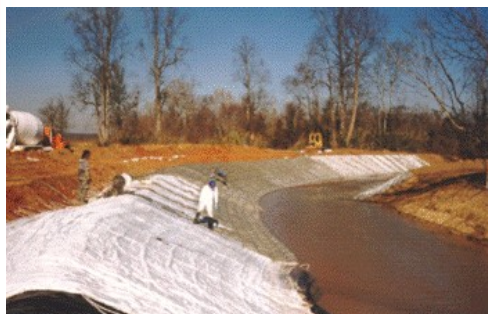
As the inflation of the ARMORFORM mats continues into the second day a dozier can be seen in the background filling in the anchor trench of the mats installed the previous day. Note the change in the color of the concrete. The freshly pumped concrete in the foreground is dark gray, while the concrete that was installed the previous day has turned to a whitish color.

The installation of the ARMORFORM panels continued into its second day with just under half of the project completed. While the inflation of the panels continued, a dozier backfilled the anchor trenches of the mats that were installed the previous day. The second day of installation proved to be much more productive, and the project was completed in the early hours of the evening. The installation of the ARMORFORM panels went without a single glitch. Over 400 cubic yards of fine aggregate concrete was injected into the ABM panels in just 2 days, and the project was completed substantially under the amount budgeted by Colonial Pipeline.

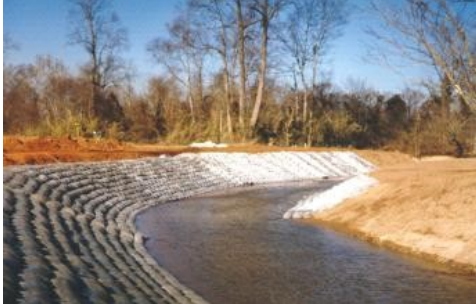
Completed ARMORFORM 6" ABM installation (looking downstream)

Nearly four years after the installation of the 6" Articulating Block Mat the creek still flows between the ARMORFORM protected embankments with no apparent damage to the system. The mats are completely intact and are providing the necessary protection to the creek's embankments to insure that the pipeline will not be re exposed.

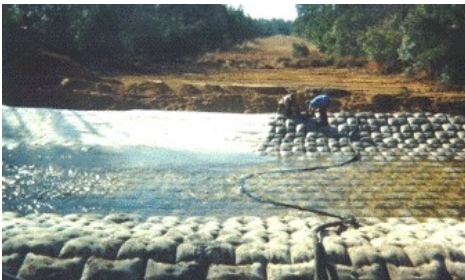
ARMORFORM ABM being installed over a fiber optic cable crossing in a shallow creek.

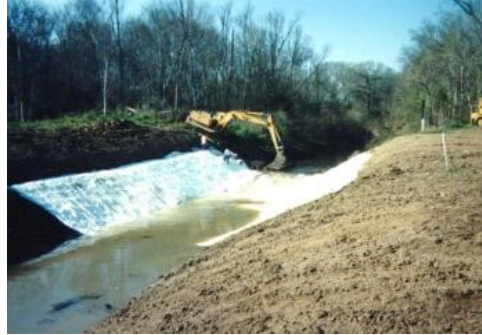
ABM mat before concrete injection (looking upstream)

ARMORFORM ABM mat being installed over a restored pipeline crossing

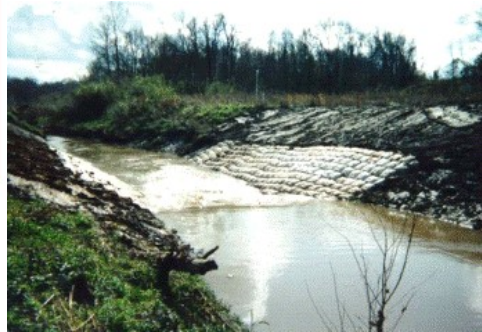
ABM Mat after concrete injection (looking downstream)
